A/C - Clicking/Popping Noise From Dash

SI B64 11 05

Clicking/Popping Noise from Dash at Startup

E85 (Z4)

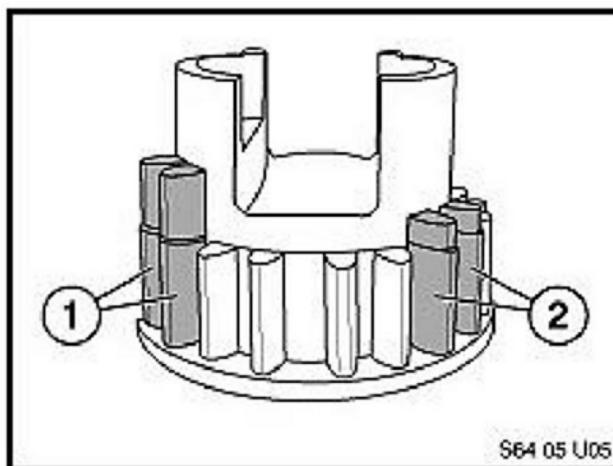
1. Remove the panel below the glove box as per RA 51 45 181.
2. Remove the glove box to gain access to the actuator for the fresh air/recirculation flap.
3. Inspect the gears that drive the fresh air/recirculation flap on the RH side of the air conditioning housing for damaged or broken teeth. Note that replacement parts are IHK dependent.

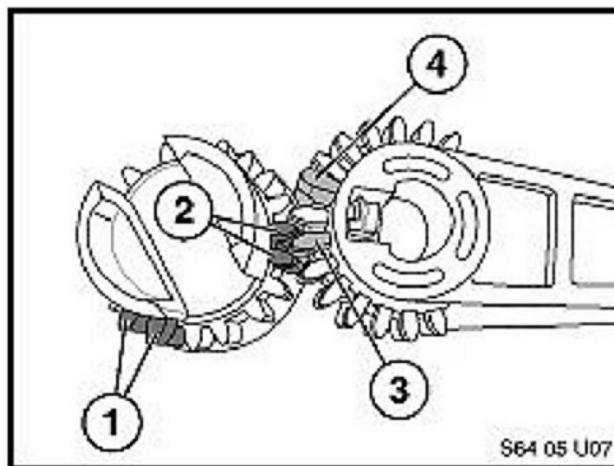
7. In the final assembled position the medium (3) tooth on the flap drive gear must be aligned between the 2 medium (2) teeth on the stepper gear.
8. Failure to properly align the 2 gears will result in a clicking/popping noise.
9. Check the operation of the fresh air/recirculation flap.
10. Reassemble the glove box and lower trim panel

6. On the flap drive gear (black), mark the tall (4) tooth and the medium (3) tooth with white touch up paint.
