**SUBJECT**

The differential input flange mating surface with the input drive pinion is insufficiently greased.

**MODEL**

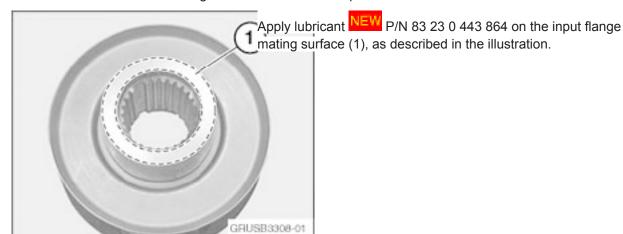
The customer complains that a single cracking or clicking noise can be heard from the rear of the vehicle while engaging a drive gear, releasing the clutch, during load reversal (shifting from reverse to drive, etc.), or when accelerating from a stationary position.

Remove the differential drive flange in accordance with Repair Instruction RA 33 11 021.

Before complete reassembly, replace the input flange seal and collar nut retaining plate as described in RA 33 01 021. Refer to the EPC for correct part numbers, based on model.
