SUBJECT

Third Brake Lamp Cracked

MODEL

E85 (Z4) from SOP to October 2003 production

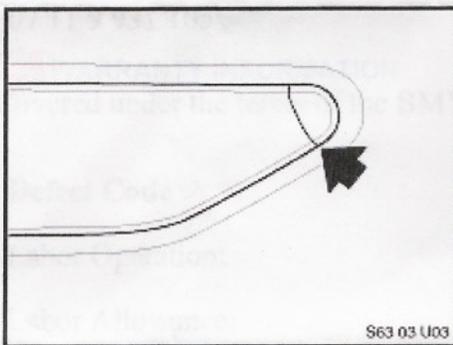
Excess spring tension caused by the 82N retaining springs may cause stress cracks in the third brake lamp.

Incorrect spring tension.

In case of customer complaint, when replacing the third brake lamp, replace the existing 82N springs with 40N springs plus an additional washer:
