# How to Remove and Replace your Soft top Motor

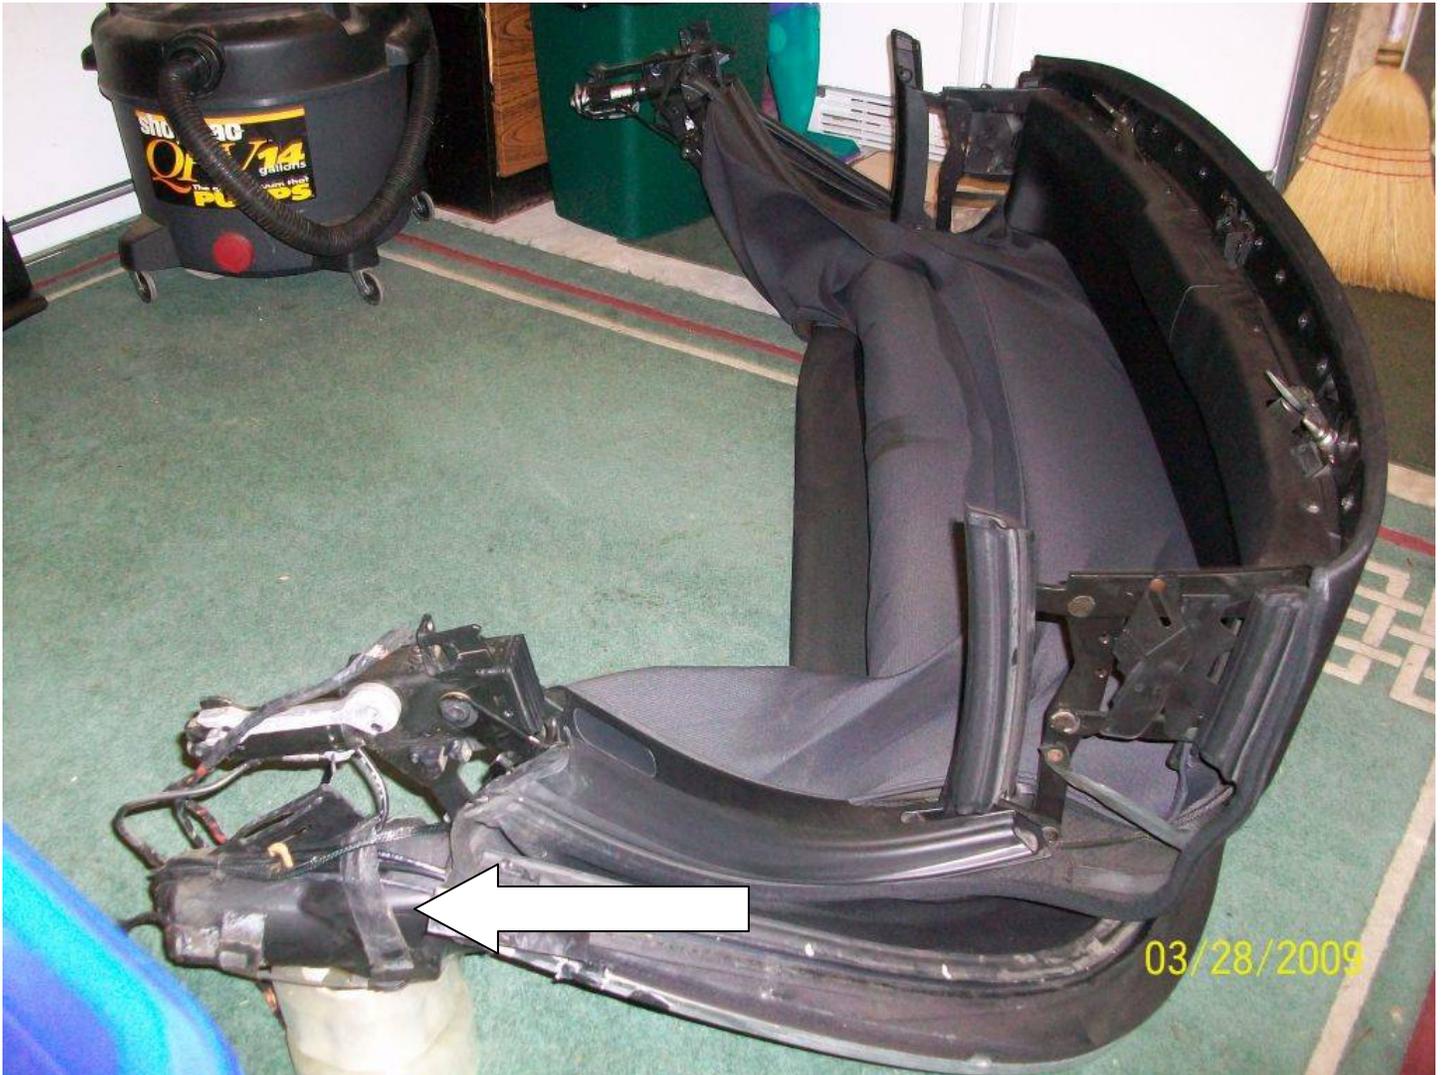
The motor is housing is designed to be attached to the top. I had a busted mount. And later on, after my first drive, I discovered that the broken motor housing, just resting in the well was the cause of the squeak/noise in my left ear while driving.... 🙄

Remove the mount from the top frame and note (Take a picture) of the wiring and hydraulic line placement.

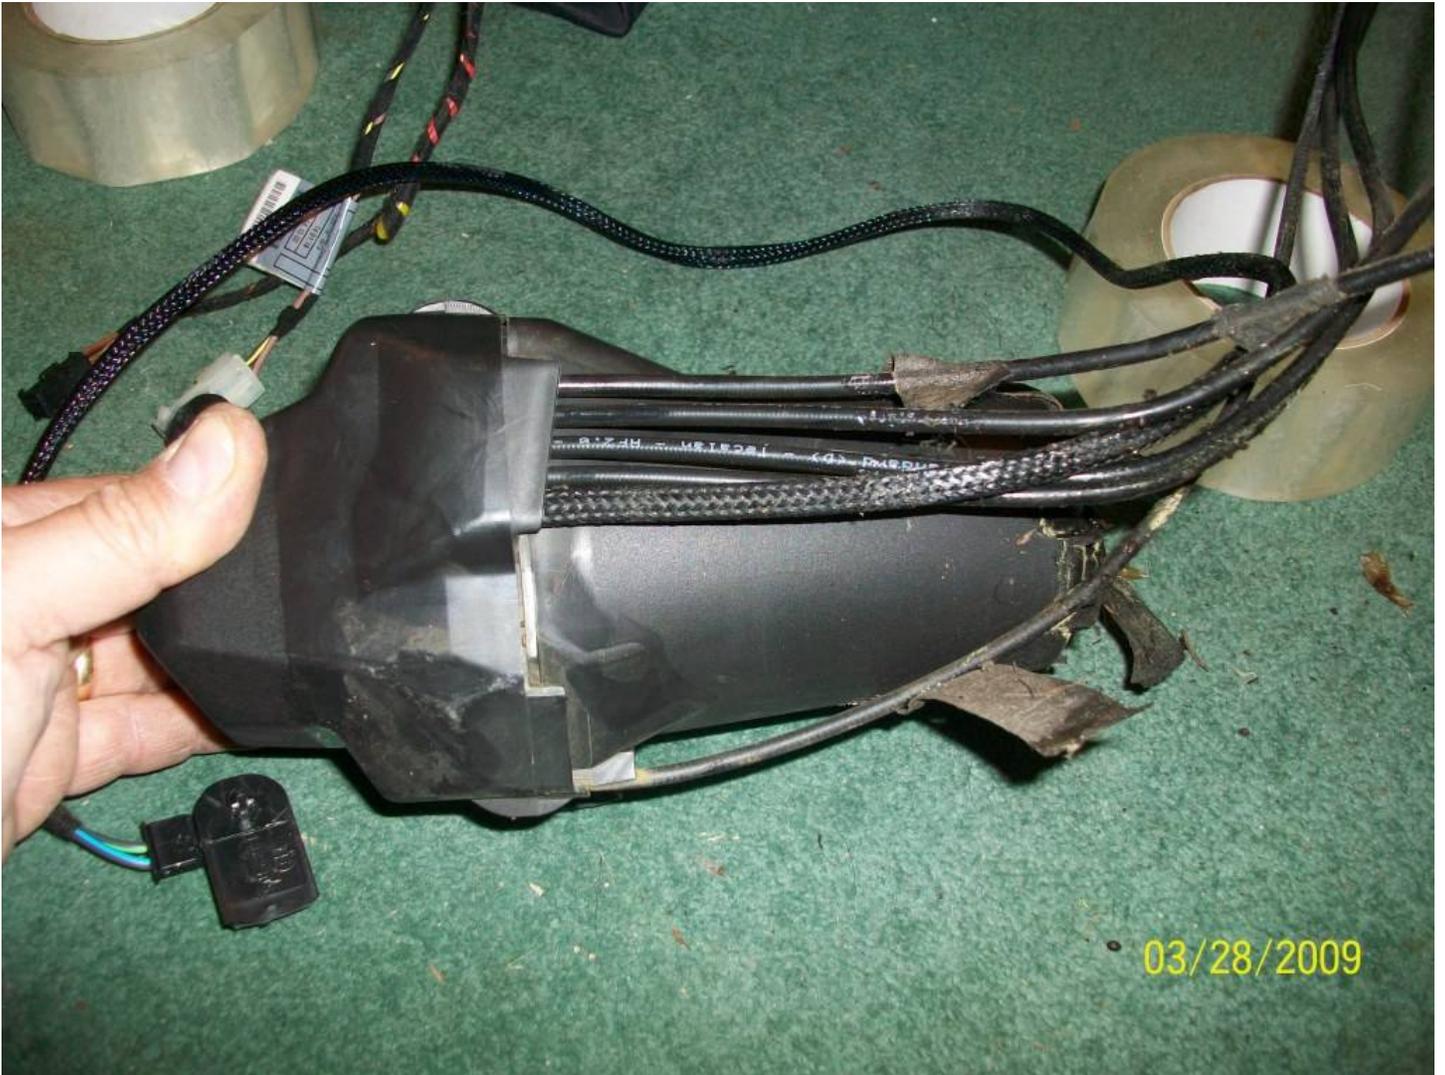
Housing cover removed. You can already see the corrosion.

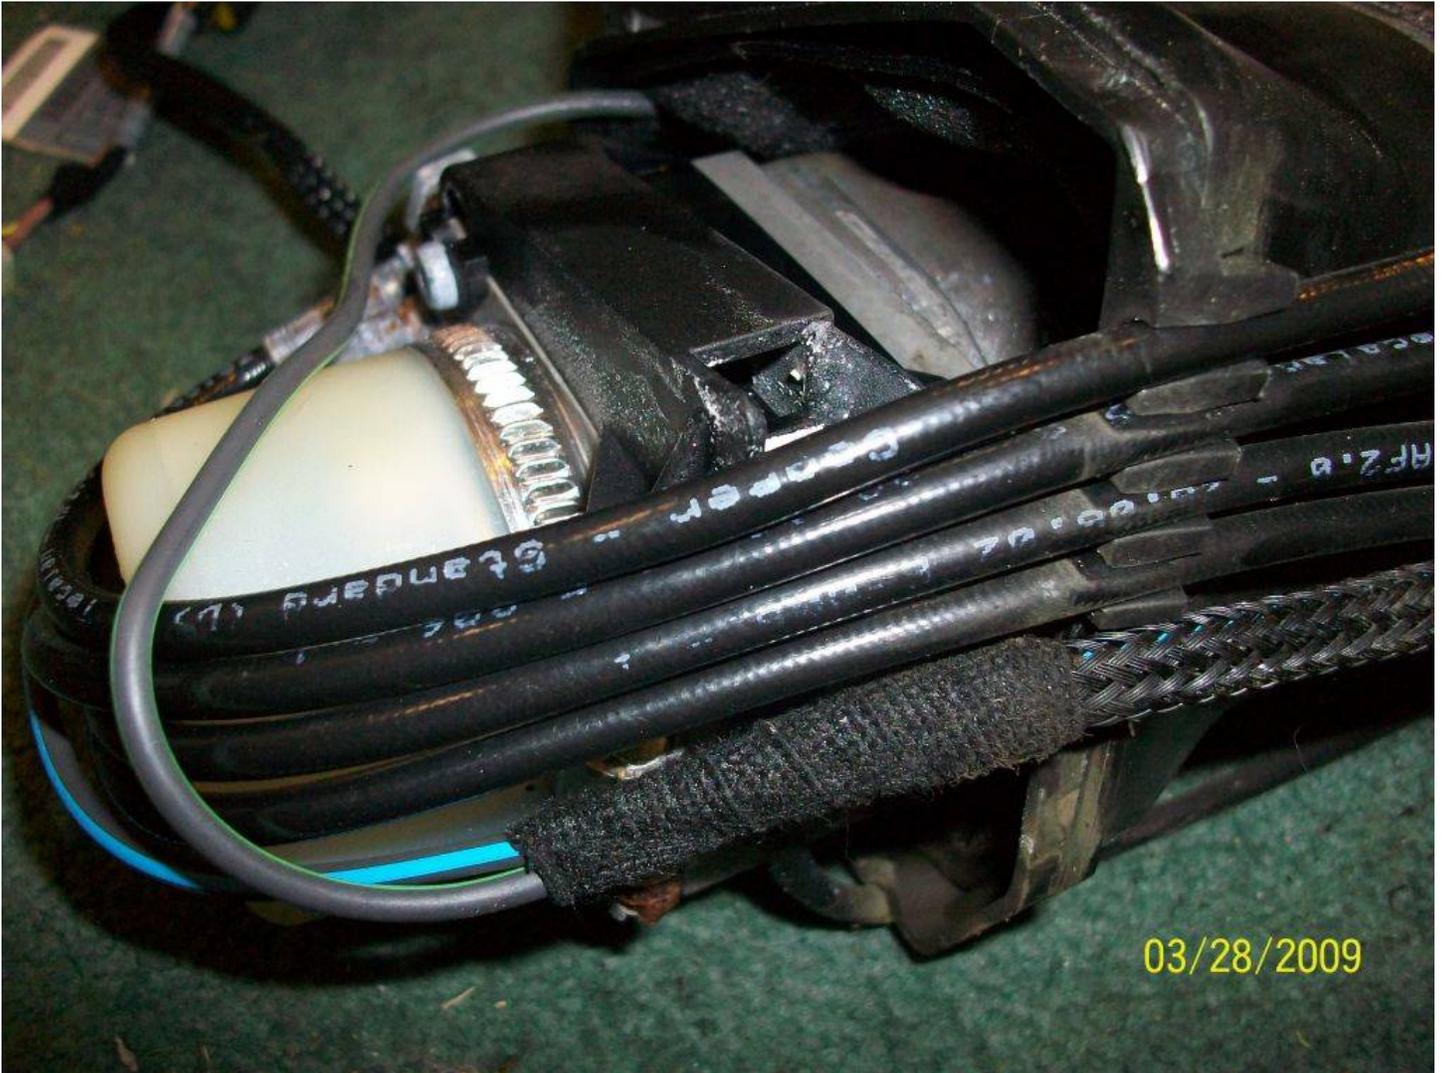
Pull out the motor. The damn thing is soaked....

Notice the wire markers...You don't have to do this, but just to be sure.....

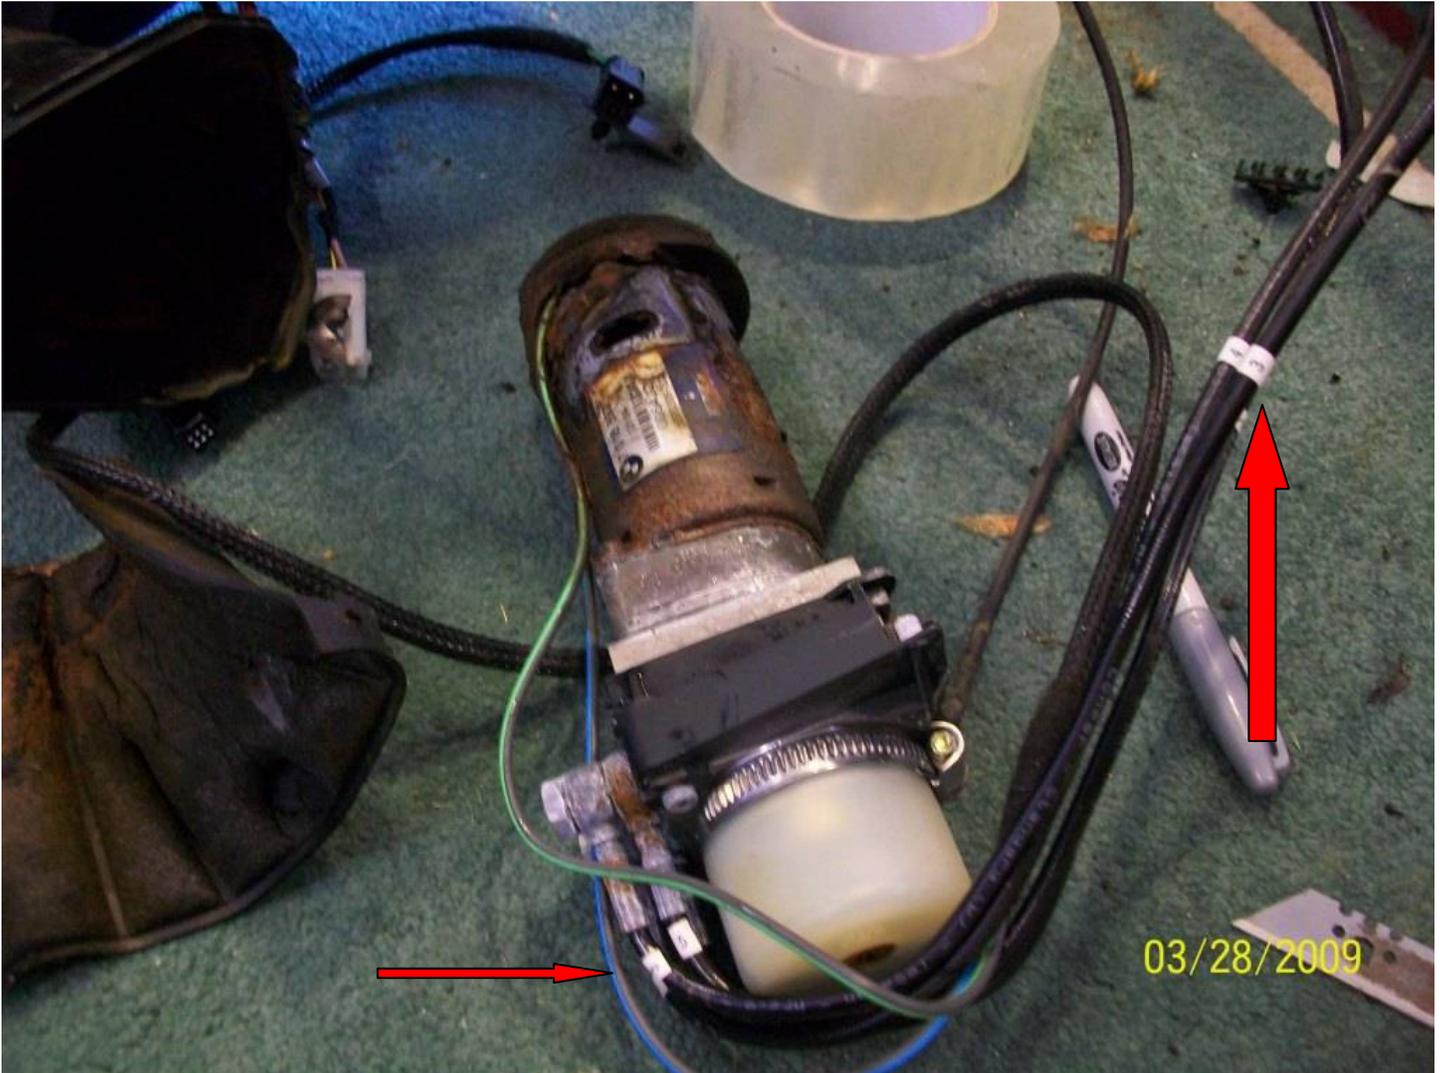
The old housing. It shows my labels and labels from BMW. 11,12,13,14 and W for the wire. Later on I found that the hydraulic lines are also labeled if you look carefully. Can't be too careful.....

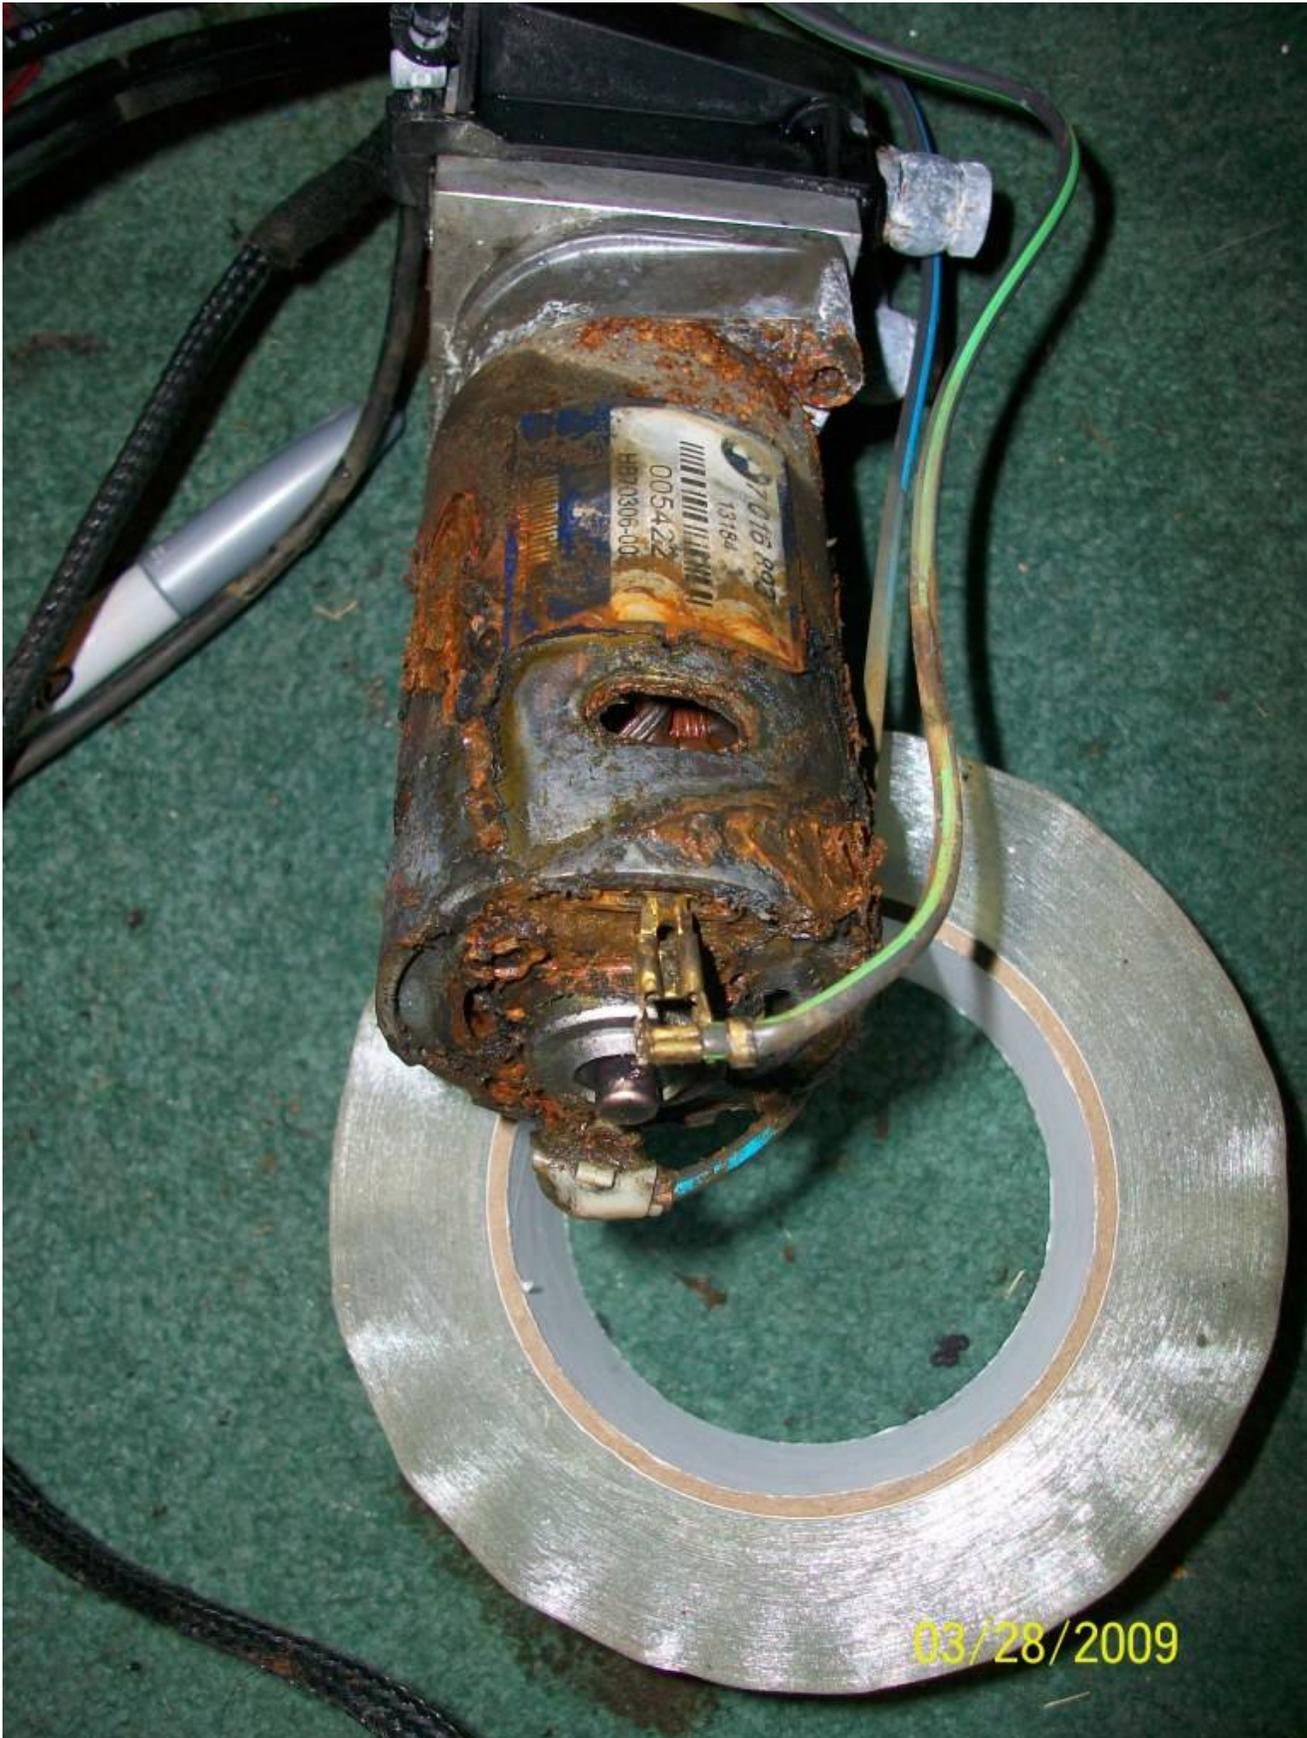
The black assembly is the Bowden Cable. It is the manual top release. Remove the three screws from the assembly, noting it's position. This is where pictures help.....

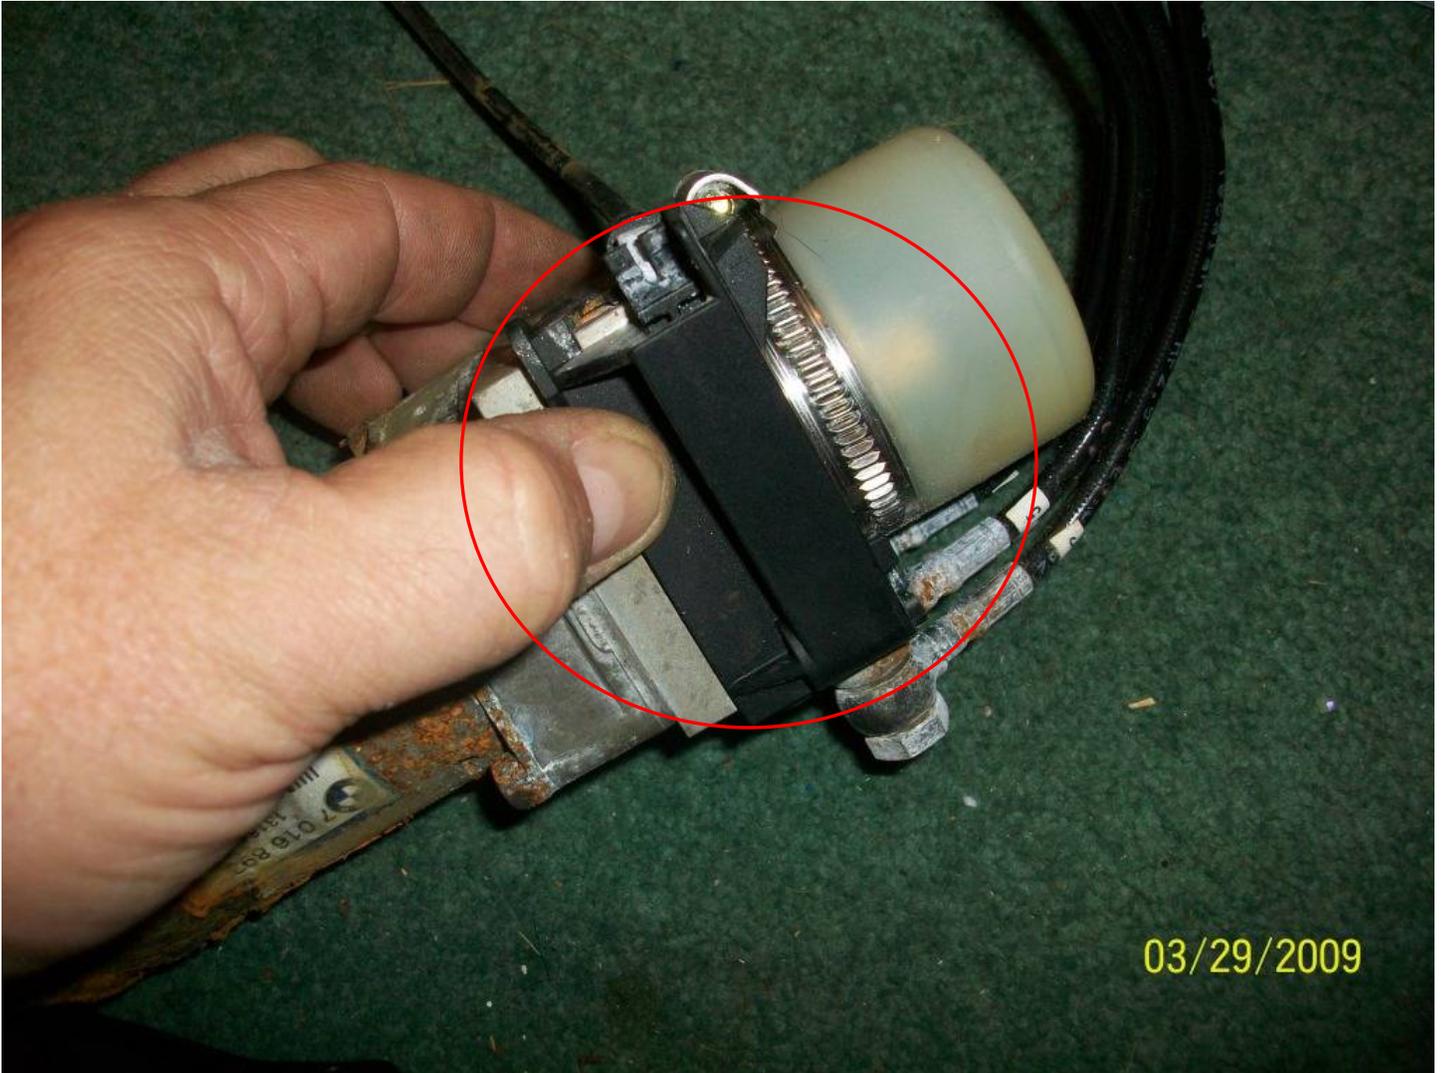
The Bowden Cable Assembly. Looking at the motor, the brass button on the bottom is the actual hydraulic by-pass plunger. This shifts the internal spool allowing oil to flow freely, without the motor driving it.

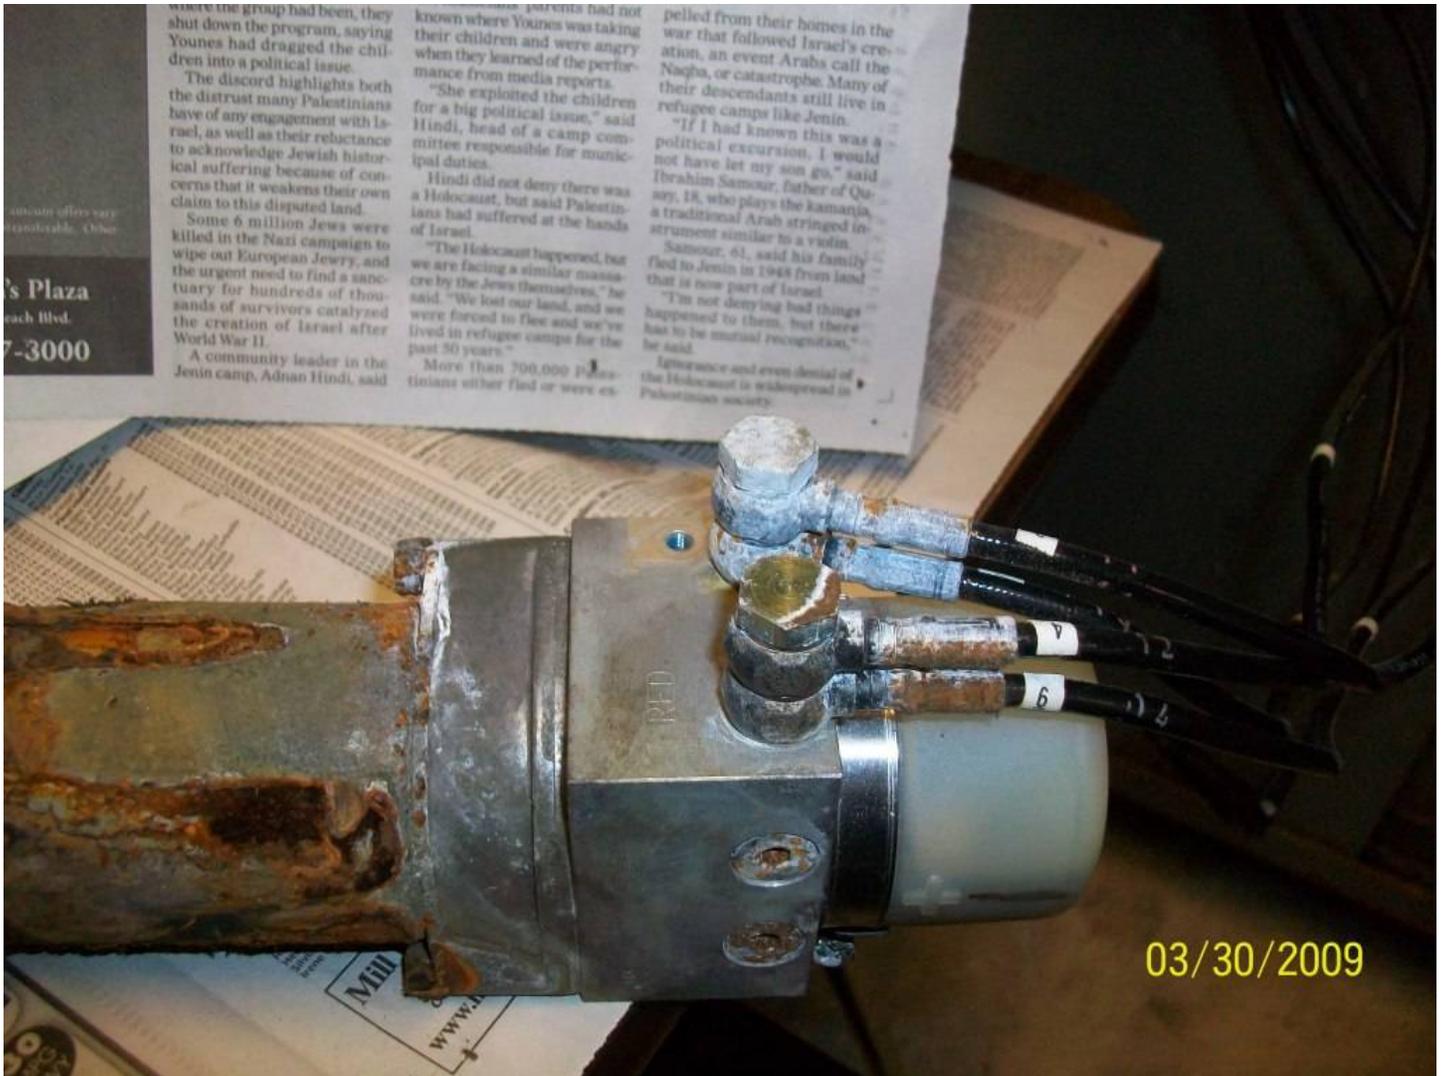
Now clean. Not perfect, but much better.
