How to UnClog your SoftTop Drains

The data and pictures were originally from the old Z4UM website. SixSpeed had an old WebCache of the site and posted it originally on ZPost.com. I have just cleaned it up and made it more presentable.

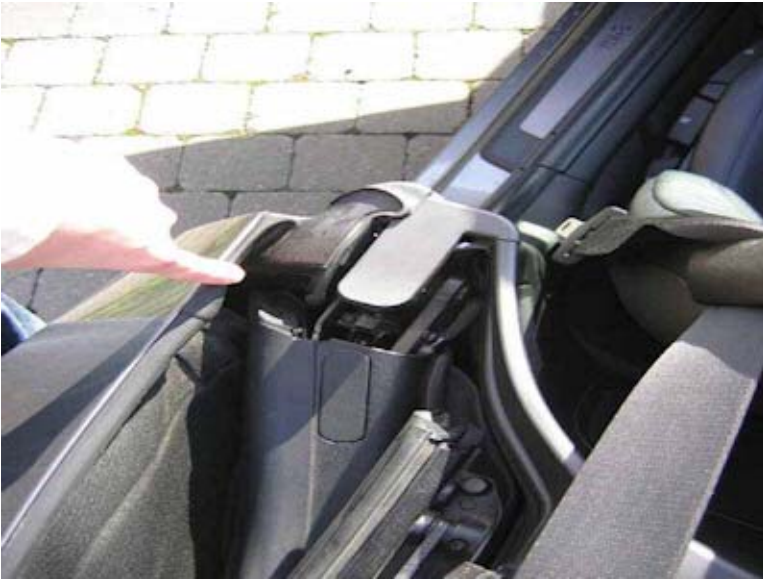
There are quite a few zzzz with a faulty soft top hydraulic system out there. The reason for the problem: WATER! The soft top motor is rapped in an insulating foam and is located in the area where the soft top folds down.

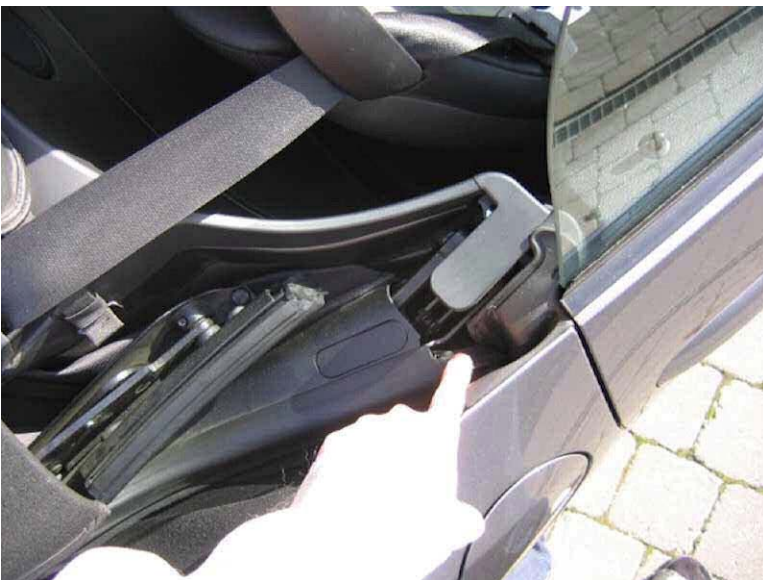
There is a water drain on each side. The drain on the right side (side of the fuel filler cap) is only visible if you watch closely between the soft top mechanism (top down) with a flashlight.

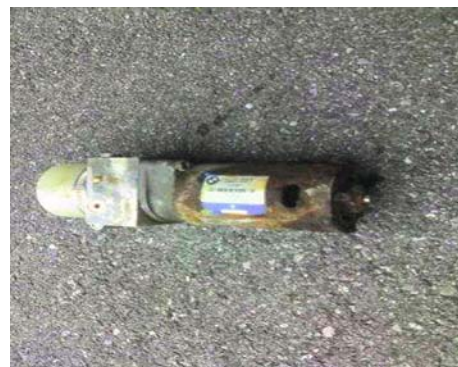
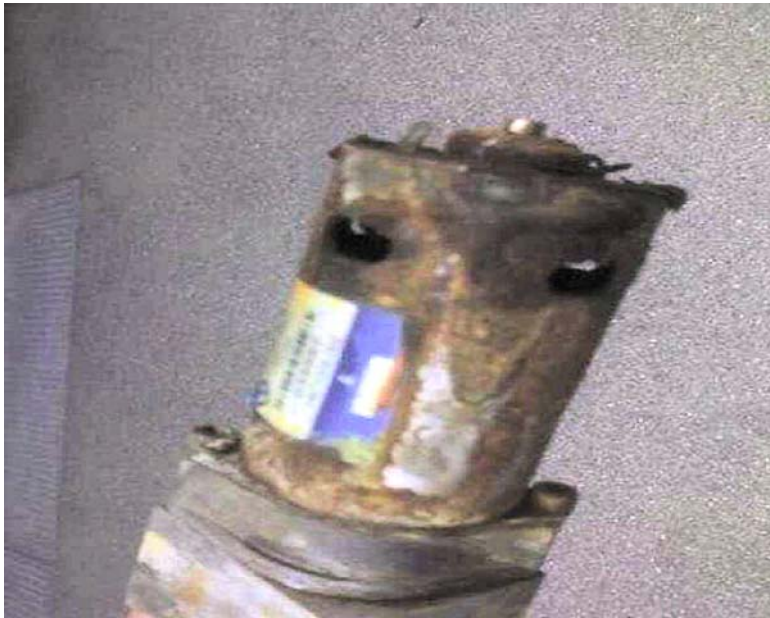
The drain on the left side is not visible because the soft top motor blocks the view. Now what happens: these drains get clogged, water can't get away and gets absorbed by the insulating foam. Result: soft top motor fails. (pic courtesy of www.zroadster.com !!!)

The repair is pretty difficult as the complete top needs to be removed to access the soft top motor (and we all know what can happen when your skilled dealer needs to do that kind of repair).

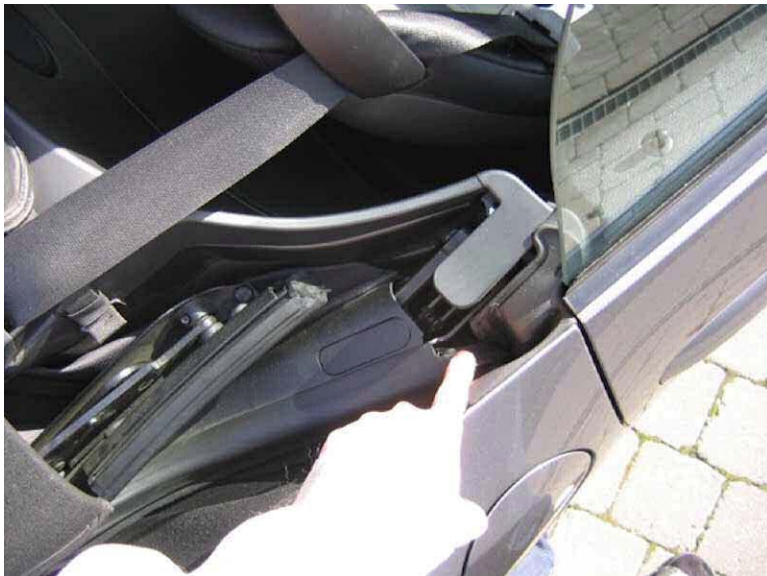
You need:

- 1 flat screwdriver
- 1 8mm spanner
- 1 10mm spanner
- 1 vacuum cleaner
- 1 tube inner diameter 6mm or 4mm
- 1 or more jack stand(s)
- 1 jack

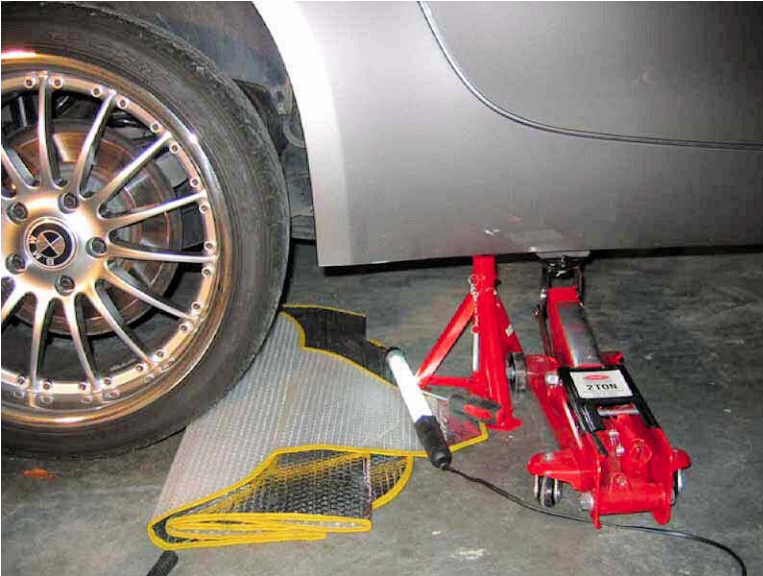
Let's start at the RIGHT side. You can see the inlet of the drain if you peek with your flashlight in the space where my finger is:

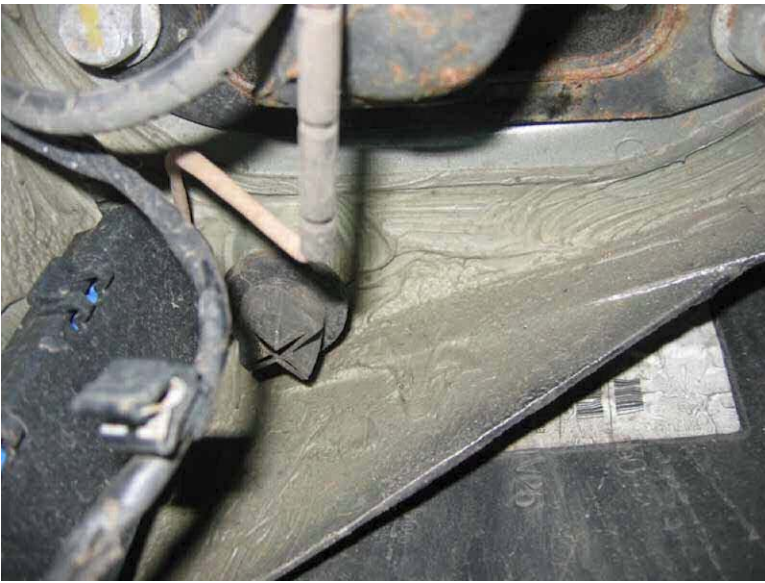
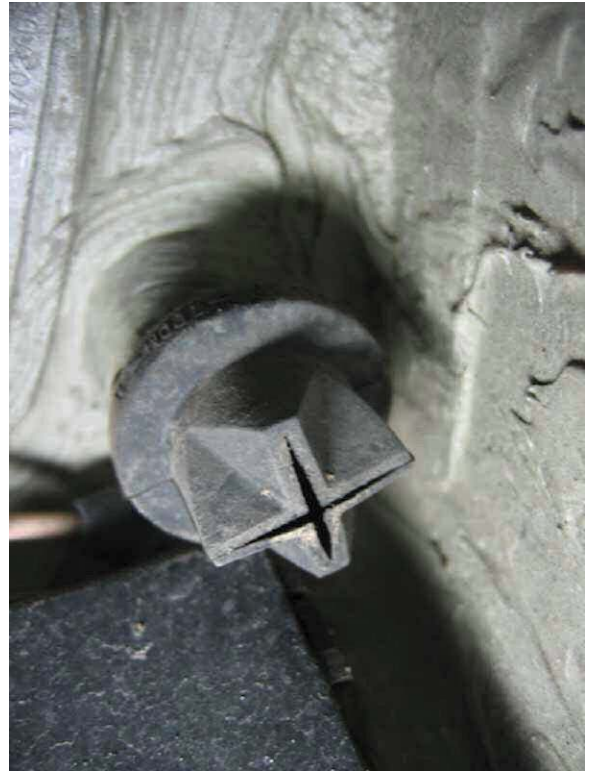
Cover and splash thingy removed. Now, get UNDER your car and you will see the drain!!

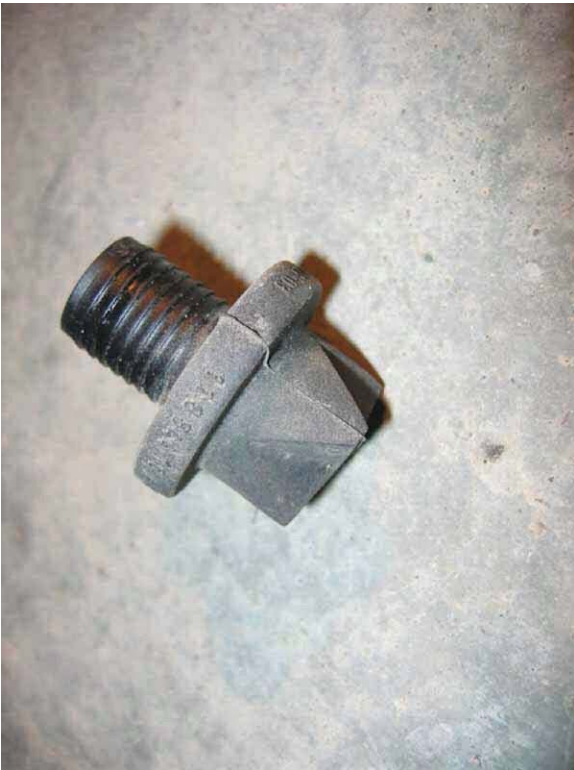
Drain removed from the car:

Whoever designed this should be shot or at least fired! The drain hole is about 8 mm in diameter, but the Internal tubing of the drain is only 5mm in diameter. Must get clogged eventually!!

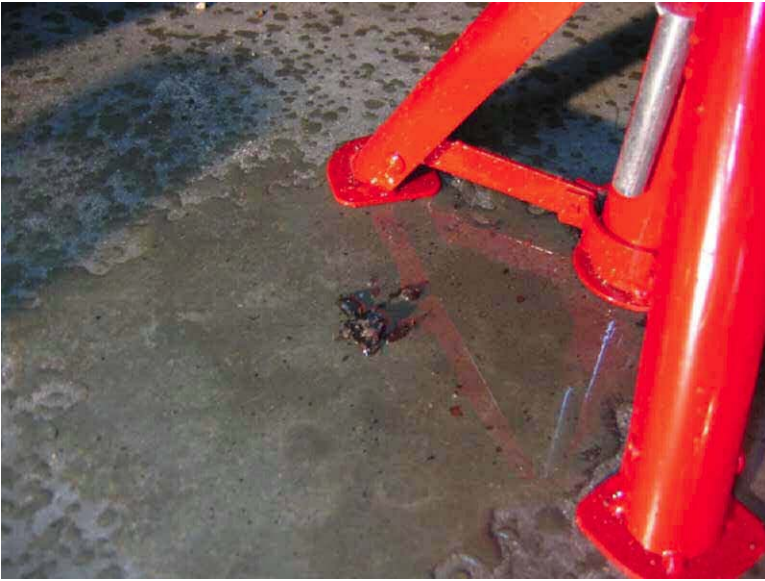
Here is a small example of the crap that came out (a lot more was flushed out with the compressed air)

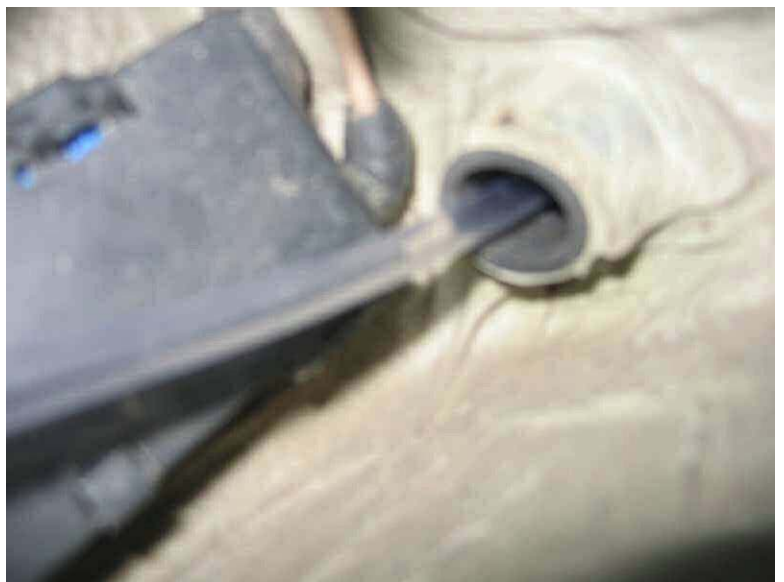
The "problem" is that you can't be 100% sure the left drain isn't clogged anymore because you can't verify it by flushing the system. But, judging by the amount of crap that came out of the drains it looks like this will be a recurring DIY Smile Don't forget to put everything back and... DONE!
